## Quantification of a Lubricant Transfer Process that Enhances the Sliding Life of a MoS<sub>2</sub> Coating

K.J. Wahl\* and I.L. Singer

*Code 6170, U.S. Naval Research Laboratory, Washington, DC 20375-5342, USA*

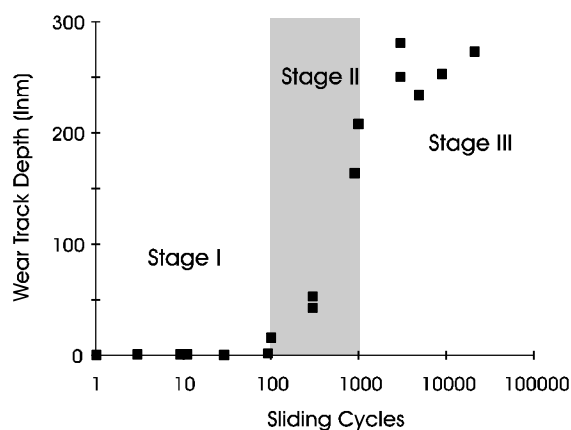
Three distinct stages of coating wear can be seen in the depth vs. log cycle curve (Figure 1). Initially, there was no measurable wear (first 100 cycles, Stage I). This was followed by a period of rapid wear to nearly the full coating

Figure 1. Wear track depths of IBAD MoS<sub>2</sub> coating measured by interference microscopy.

thickness during the next 1000+ cycles (Stage II), and finally a long period of low average wear for the remaining ~20000 cycles (Stage III). Friction coefficients remained low (0.02 to 0.06) throughout testing until late in sliding life near failure at ~21000 cycles.

The buildup and depletion of material on track and ball surfaces was quantified using EDS and is shown in Figure 4. The material loss in the tracks agrees with the optical interferometry result (Figure 1), as expected for dense coatings. Most dramatic is the buildup (Stage II) then depletion (Stage III) of material in patches at turnaround points. The buildup occurred during the period of rapid coating loss from tracks in Stage II. Depletion of these patches to nearly zero thickness occurred during more gradual loss from tracks in Stage III. On balls, a continuous buildup of a relatively thin transfer film was observed. (The ball transfer film at failure contained significant amounts of oxygen, making it difficult to determine the thickness by EDS.)

Here we carry that argument one step further: we contend that the endurance of a MoS<sub>2</sub> coating (in dry air environment) is not determined simply by the wear rate of MoS<sub>2</sub> but rather by the dynamics of the replenishment process illustrated in Figure 5. The track depths (Figure 1) and coating losses (Figure 4) determine the *net loss of material* from the track rather than a coating “wear rate.” The amount of lubricant in the track is established by both

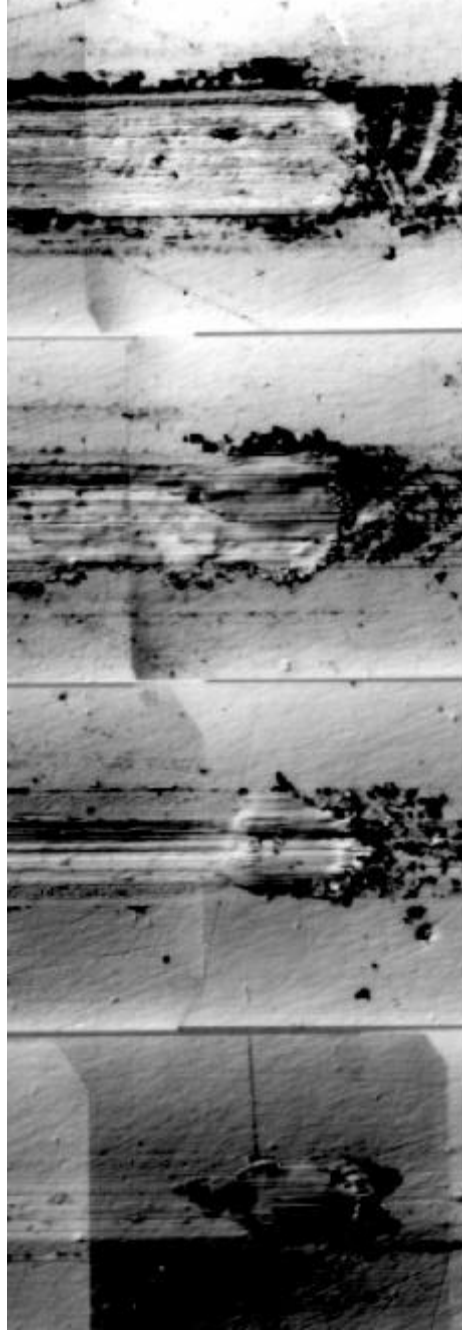
Figure 2. Micrographs of MoS<sub>2</sub> wear tracks and end patches, taken near the turnaround point in the middle of each track. (9000, 3000, 900, and 300 cycles from upper to lower.)

associated with each stage of wear. During Stage I, tracks appeared burnished, with only a small amount of debris at the turnaround points. The tracks at the turnaround points (Figure 2, 300 and 900 cycles); these debris patches appeared thinner or absent by Stage III (Figure 2, 3000 and 9000 cycles). In addition, during Stages II and III, material was ejected from the contact and deposited as loose debris along the edges and beyond the ends of the tracks.

The observed progression of wear morphology (Figures 2 and 3) along with quantification of thickness changes (Figure 4) can be interpreted as a lubricant transfer process diagrammed in Figure 5. In Stage I, a film transfers from the coating to the ball surface, and a small amount of the lubricant is deposited in patches at the turnaround points directly from the coating or indirectly from the ball transfer film (Figure 5a). During Stage II (Figure 5b), some of the lubricant lost from the track is transferred to patches at turnaround points and onto the ball; these deposits can act as reservoirs to replenish lubricant lost from the sliding contact. At the same time, some of the lubricant is ejected (as debris) beyond the track and ball contact zone and excluded from participation in the replenishment process. During the long period of sliding, Stage III (Figure 5c), the reservoir provided by the end patches becomes depleted as it replenishes lubricant to the track. Meanwhile, some material continues to be ejected and lost during the sliding process.

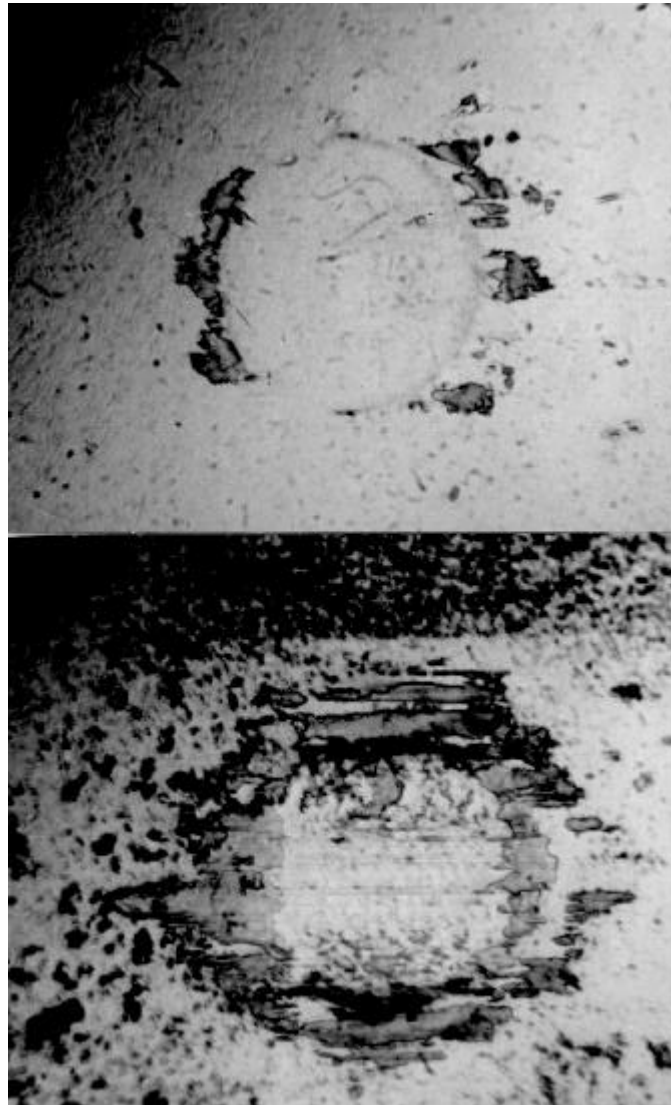
On the ball surfaces, transfer films began forming during the first few sliding cycles. The transfer films were distributed in and around three distinct regions of the contact [10]. During Stage I, a very thin film of MoS<sub>2</sub> was transferred to the center of the contact (as determined by AES) and compacted debris was collected around the border of the contact zone (Figure 3a). During Stage II, more material was observed in and around the contact zone, and loose debris accumulated outside the contact zone (Figure 3b). The transfer process continued in Stage III, with increasing amounts of debris in and around the contact.

Figure 3. Transfer films formed on steel balls during sliding against IBAD MoS<sub>2</sub> coating after (a) 9 and (b) 900 cycles.

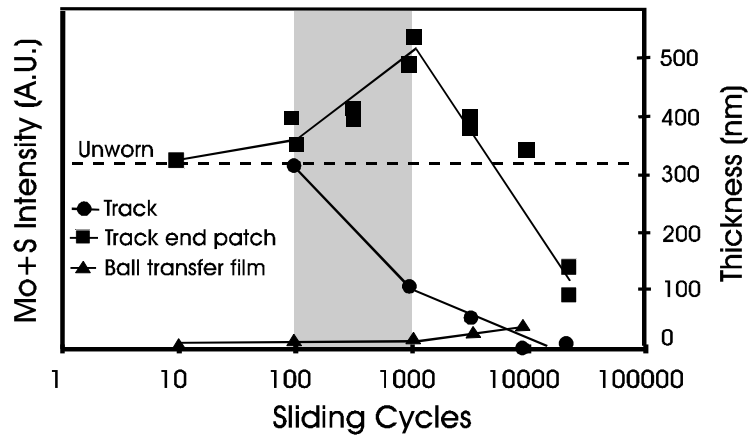
Figure 4. Track, patches at turnaround points (track end patch), and ball transfer film thicknesses measured by EDS.

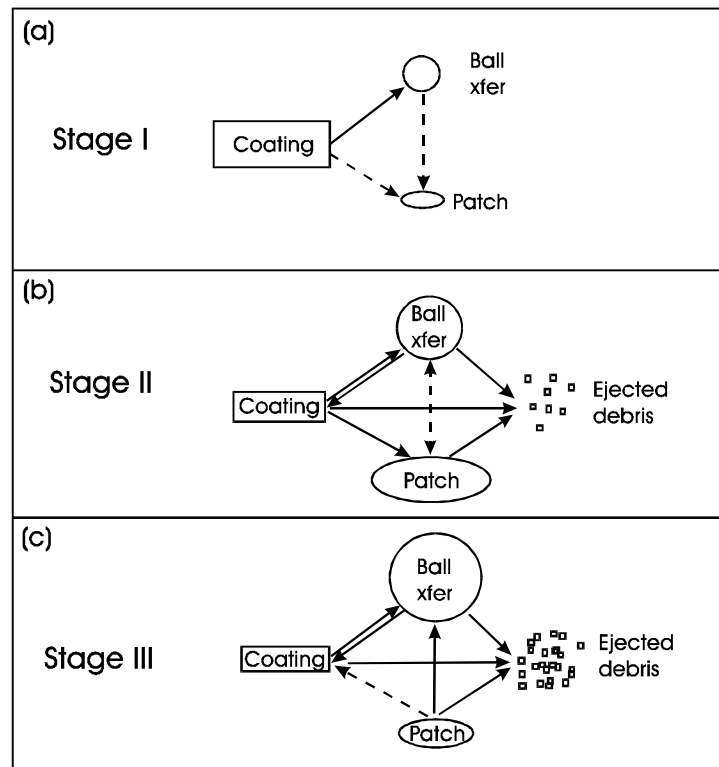
Figure 5. Schematic representation of the transfer processes between the coating wear track (coating), ball transfer film (ball xfer), and patch material at turnaround points (patch) for (a) Stage I, (b) Stage II, and (c) Stage III sliding. Solid lines indicate observed material transfer directions, while dashed lines indicate other possible transfer routes.

The individual processes illustrated in Figure 5 have been documented in earlier studies. Fleischauer et al. [4] as well as Ehni and Singer [11] have shown
